Chapter 4: Lady Victoria Colliery

Situated on the Lothian coalfield to the south of Edinburgh (see Figure 5.160 in the Gazetteer), Lady Victoria Colliery¹ is an outstanding example of a model colliery dating from the late 19th century when the Scottish coal industry was reaching its peak, both in terms of size and sophistication. It is also remarkable because, in the 110 years since it first began to produce coal, deep coal mining in Scotland has disappeared entirely, and the surface remains of all collieries have either been entirely erased, or have been radically altered to such an extent that they are no longer immediately recognisable as having been collieries. Almost all of Lady Victoria's surface arrangement survived relatively intact following closure in 1981 (see Figure 4.1), and as such the complex provides much information on the content and arrangement of a large colliery site as it evolved through the 20th century.

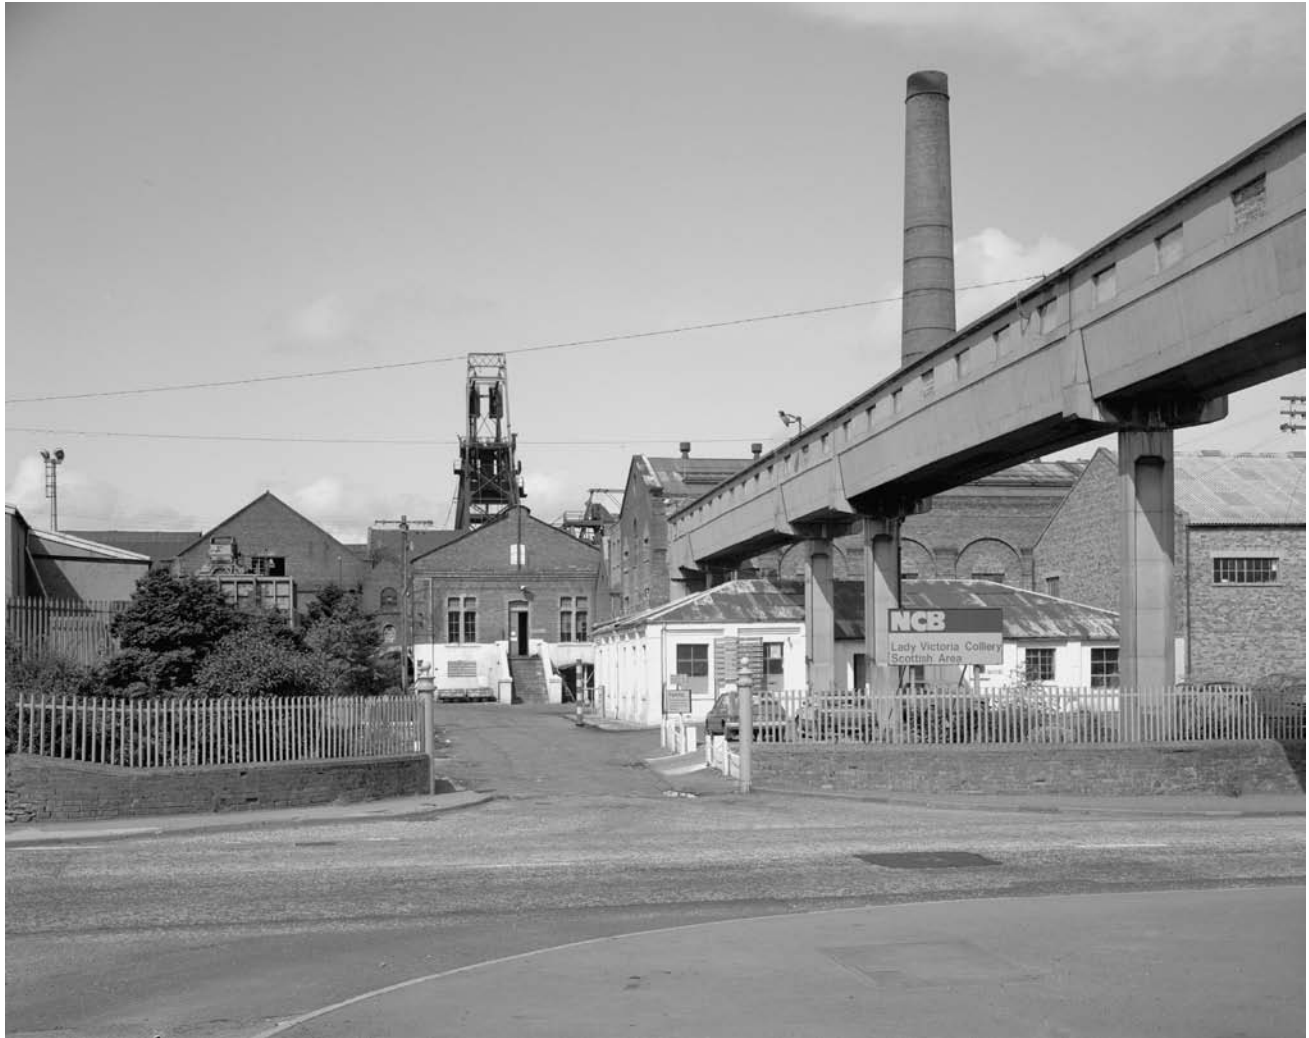
Figure 4.1: View of Lady Victoria Colliery, shortly after the cessation of mining in 1981. SC894658

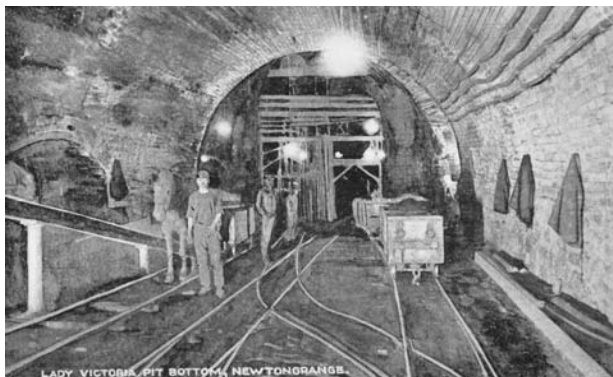
Figure 4.2: Lady Victoria Colliery, 1929. A postcard showing the pit bottom, suggesting that pit ponies were still in use at the time. SMM:1997.0909, SC382531

In its second year of operation, 500 tons of parrot coal were being hauled up the shaft daily, and a year later the addition of splint coals raised the total to 600 tons. In the years that followed, the management were quick to modernise, introducing, for example, new designs of face support which helped to reduce the accident rate from rock falls to one fifth the Scottish average. In the 1920s, miners were provided with electric lamps in the dustier working areas of the pit where coal-cutting machinery was in use, but naked lights were still used elsewhere for many years. The original haulage roadways were constructed to be 3.05 metres wide and 2.59 metres high, but were enlarged to 3.66 by 3.05 metres after an increase in the size of the hutches. Underground endless-rope haulage was also introduced, replacing 120 ponies (see Figure 4.2).

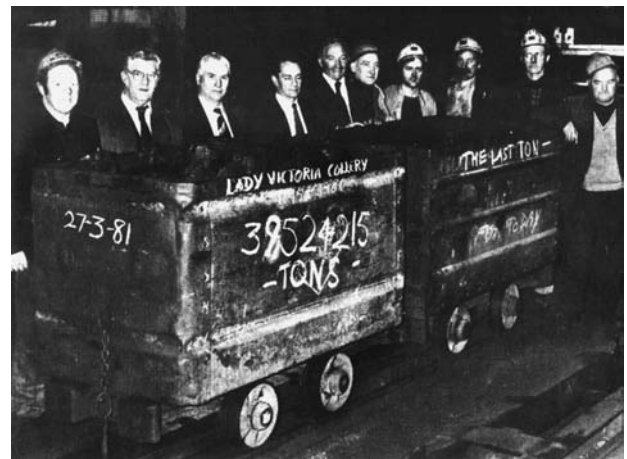
Figure 4.3: Lady Victoria Colliery, 27th March 1981. The last ton of coal to be mined at the colliery, which was said to have yielded over 39 million tons of coal in its lifetime. *Dalkeith Advertiser*, SC384780

Hood had experimented with early types of coal cutter at Whitehill Colliery in 1877, but these had been unpopular, especially because they created a lot of dust. At Lady Victoria, Mavor and Coulson bar-type cutters were successfully introduced in 1905, and were later replaced by chain-type cutters by the 1950s. These in turn were replaced in the 1960s by shearer loaders along with armoured conveyors. In 1947, the first full year of nationalisation, the colliery produced 340,000 tons, which was equivalent to 1,246 tons per day, rising to 2,000 tons per day by 1951. At its peak in 1953, the labour force reached 1,765 people, of whom 1,360 worked underground. By 1969, face mechanisation had led to a reduction in manpower to 1,247 men, and by 1979, to 895, greatly reducing the hard manual labour involved in extracting the coal. Two years later, on 27th March, 1981, the last ton was mined and the colliery closed after 87 years of operation, in which time almost 40 million tons of coal had been extracted (see Figure 4.3).

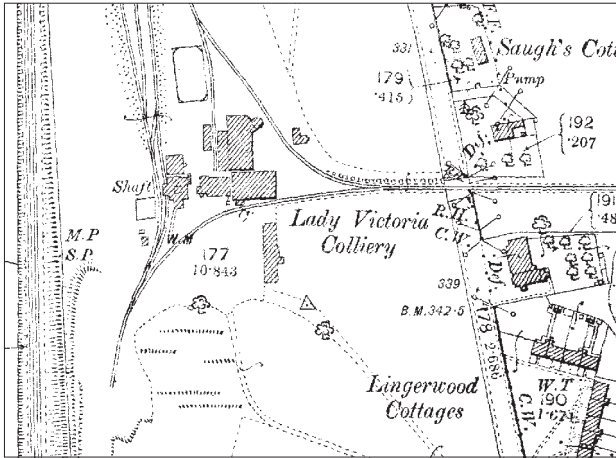
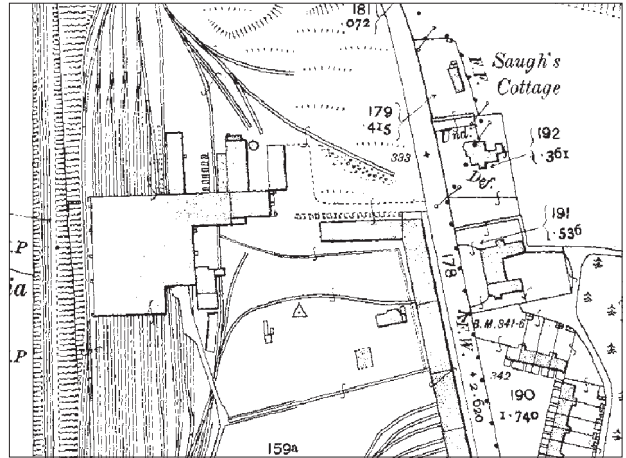
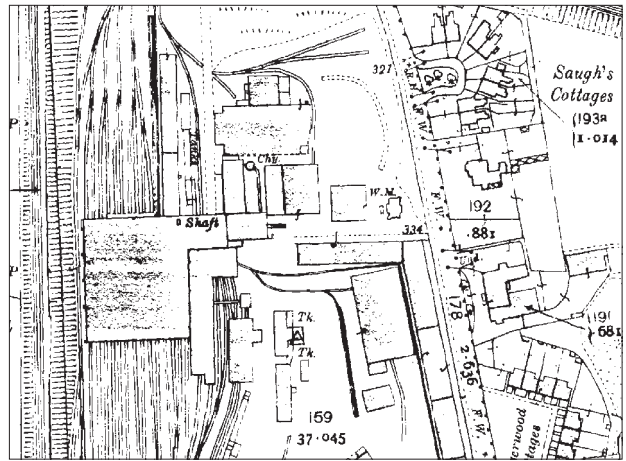
Figure 4.4: The evolution of Lady Victoria Colliery, as depicted on Ordnance Survey maps, (25 inch : 1 mile). Crown Copyright 2003, All rights reserved: RCAHMS GD GD03135G0011

identified (in an anti-clockwise direction). An accompanying table (Table 1) provides a brief description of each component of the colliery, and with the assistance of Ordnance Survey maps (see Figure 4.4), it has been possible to date most elements of the surface arrangement. In addition to RCAHMS survey photographs, images from the museum's own collections have been used to illustrate various areas and processes, and are arranged in the same order as that in which they appear in Table 1.

(see Figures 4.4 and 4.5)

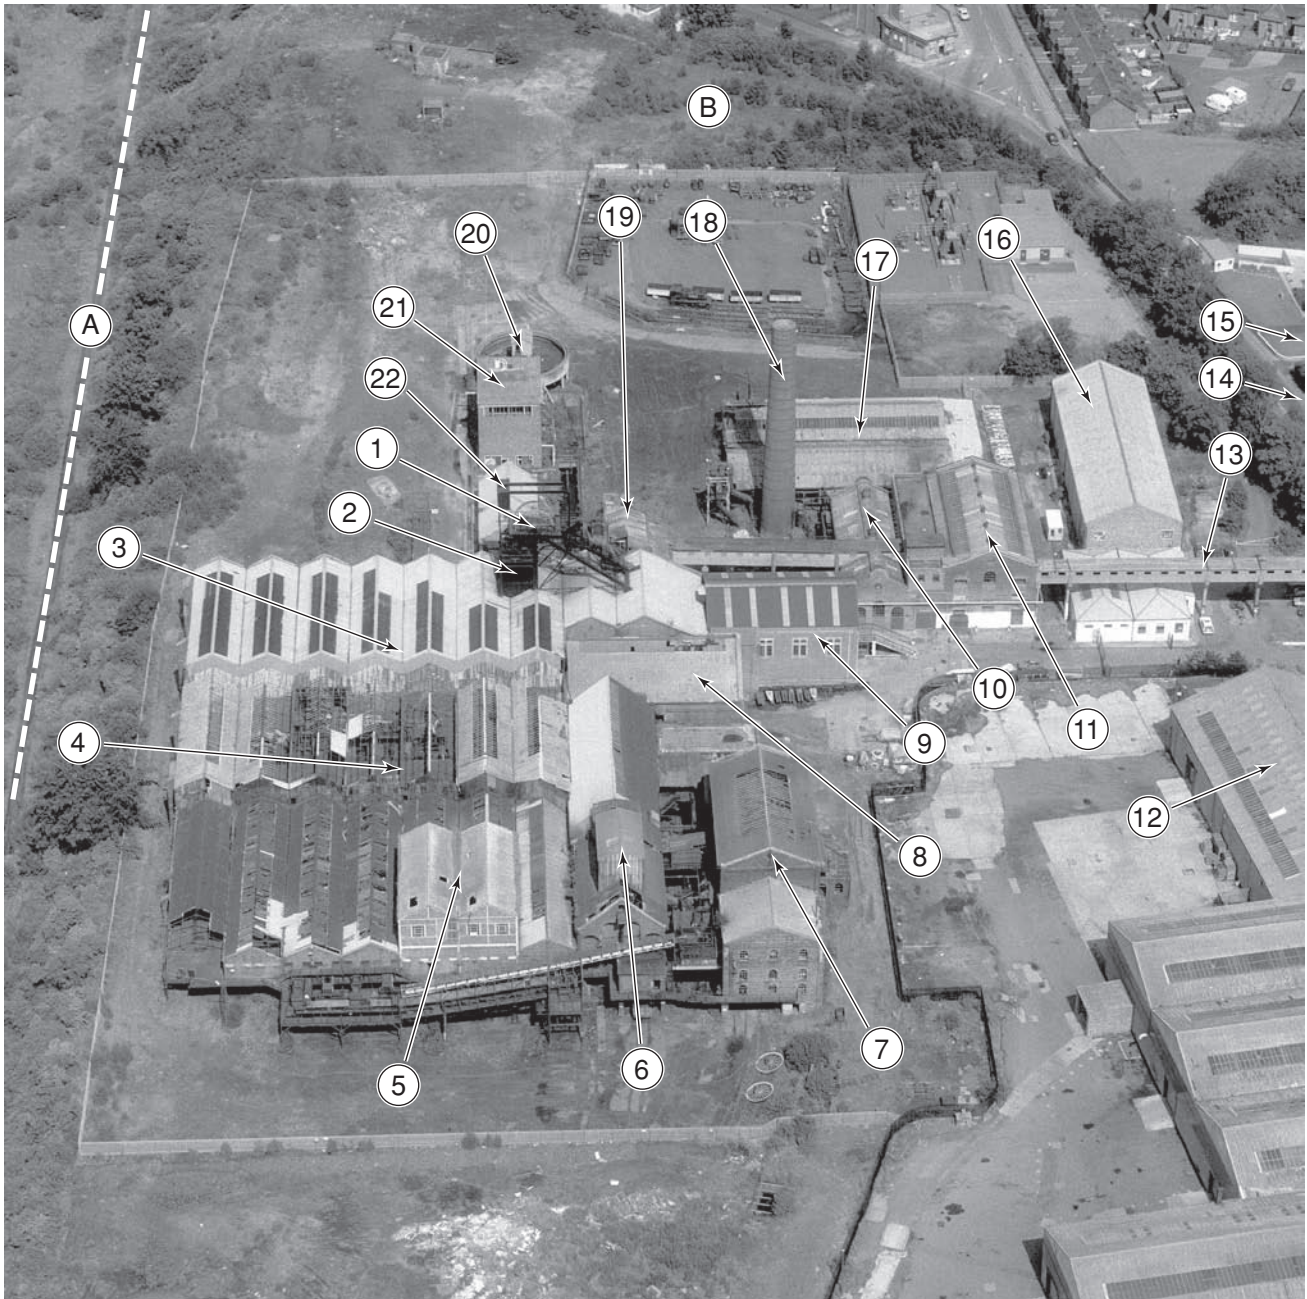
Figure 4.5: Lady Victoria Colliery: aerial view of the surface arrangement, highlighting the major components of the colliery.

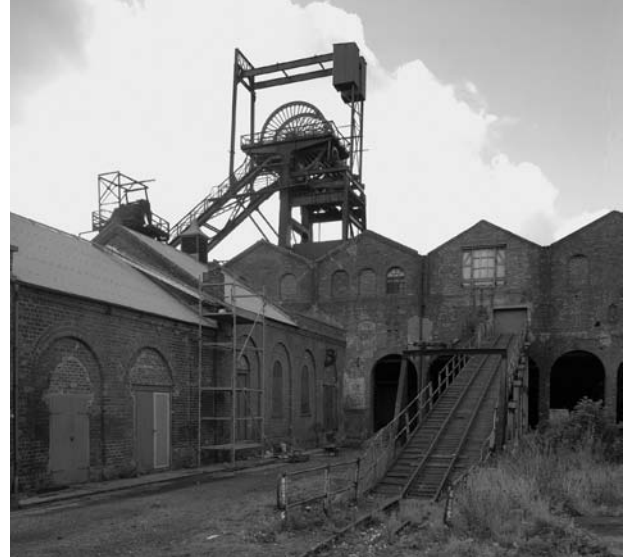
Figure 4.6: Lady Victoria Colliery, 1988. View from north west showing headgear, part of the north side of the pithead complex, and to the left, the old engine house originally used to house the temporary winding engine during the sinking of the shaft in the early 1890s. SC758215

1 Headgear: 26 metres high, and constructed from fabricated mild steel by Sir William Arrol and Company of Glasgow in 1893, with two sheaves (or pulleys), each of 5.79 metres diameter (see Figure 4.6).

22 Engine Houses and Workshops: a partially truncated brick-built single-storeyed, gabled range situated on the north side of the pithead, and thought originally to have housed the winding engine used to sink the shaft in the early 1890s. It later housed an electric engine used to drive continuous-rope underground haulage (see Figure 4.6).

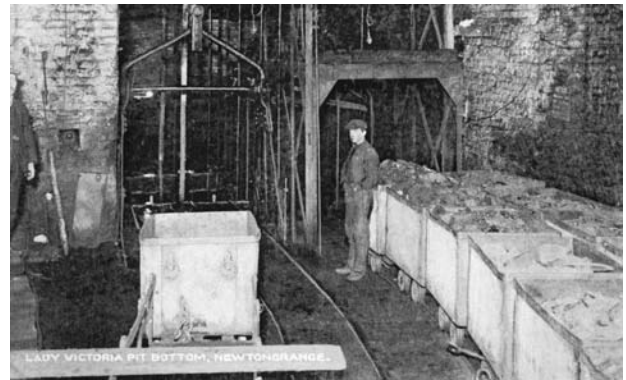
Figure 4.7: Lady Victoria Colliery, c.1920. View at the pit bottom showing hutches ready to be loaded into the cages. SMM:1997.0876, SC382546

2 Shaft: sunk and simultaneously lined with brick during a four year period between 1890 and 1894 to a depth of 501 metres, and with a diameter of 6.09 metres (20 feet) which was at the time the largest circular shaft in Scotland. In addition to containing the two cages, this was the downcast shaft, air from the colliery being exhausted through an upcast shaft at neighbouring Lingerwood Colliery. After closure in 1981, the shaft was blocked, and all the mineworkings below are now inaccessible (see Figure 4.7).

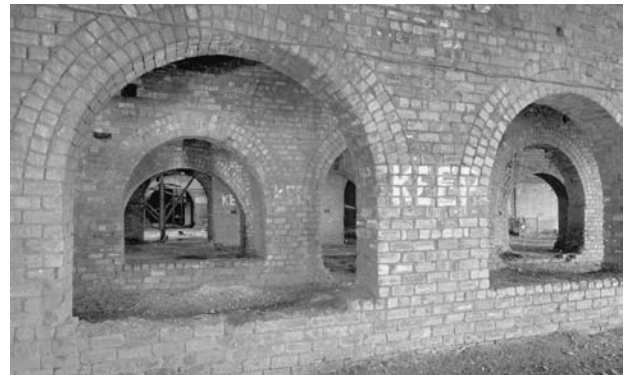
Figure 4.8: Lady Victoria Colliery, 1999. View beneath the picking tables showing the arcades of brick arches separating the railway sidings which passed under the colliery. SC894274

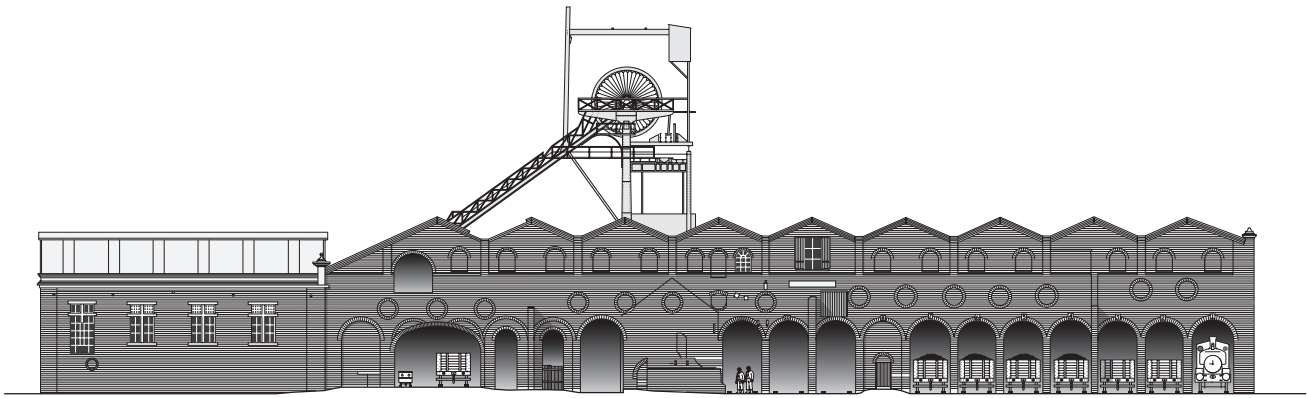
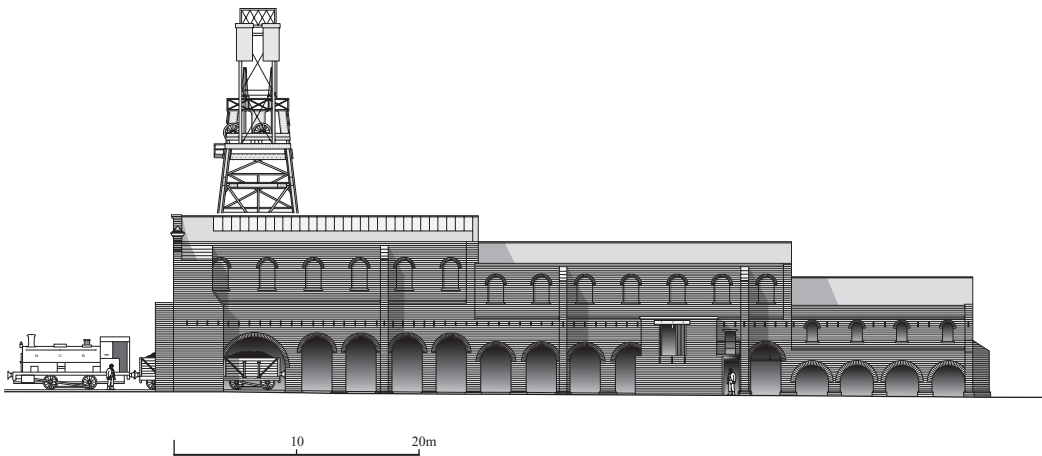
Figure 4.9 Lady Victoria Colliery, 2000: the north (top) and west (bottom) elevations of the main pithead building, including the headframe.

3 Pithead: a mostly two storeyed complex of steel-framed buildings with red-brick walls (see Figure 4.9), which at ground level accommodate railway sidings (formerly connected to the mainline railway) separated by arched brick walls, between which railway wagons were filled with coal from above (see Figures 4.8, 4.9, 4.10). Much of this structure was built between 1894 and 1907. The upper level contains a circuit around which tubs or hutches of coal circulated, having been unloaded from split-level cages (see Figure 4.11). The circuit contains a weighing station, and tipplers which overturned the hutches, their contents being collected below on conveyors (see Figure 4.12). The circuit was designed to operate on a gentle slope to allow gravity to do much of the work, but a creeper (see Figure 4.13) took the hutches back to the shaft (see Figure 4.14). The original arrangement had double-decking at both the pit-head and the pit-bottom to permit simultaneous loading and unloading of both decks of each cage. Despite the reconstruction of the tub circuit in the 1960s and the reduction from double to single decking, the slight slope towards the winding engine house (to the east) can still be detected.

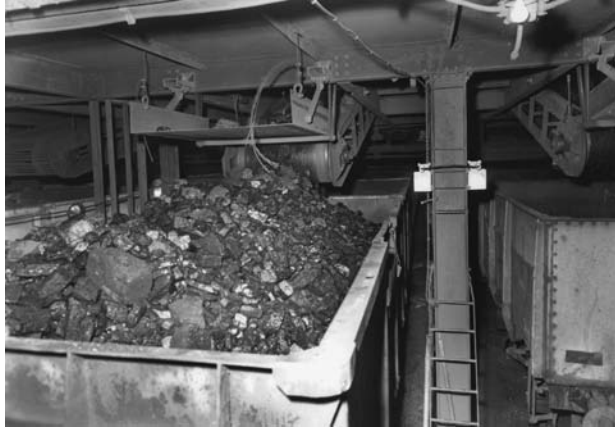
Figure 4.10: Lady Victoria Colliery, 1964. View of coal discharging into railway wagons beneath the picking tables. SMM:1998.0397(xiii), SC384759

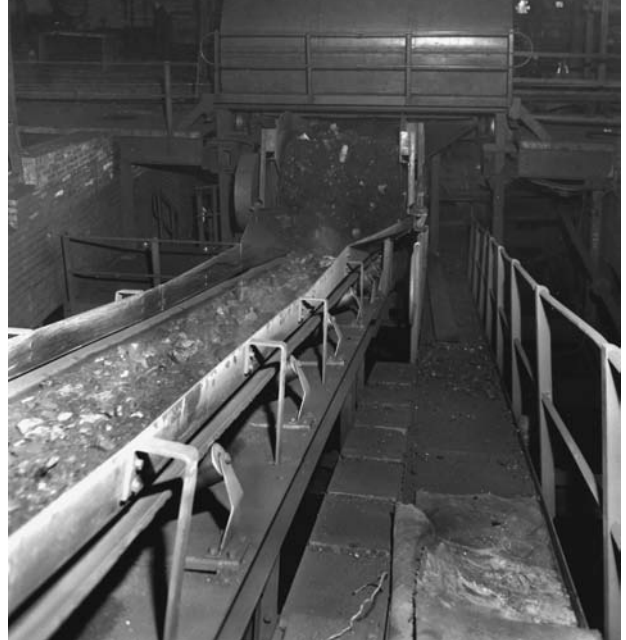
Figure 4.12: Lady Victoria Colliery, 1963. Interior view of conveyor from pit-head tippler, which can be seen in the background. SMM:1998.0397(iii), SC384754

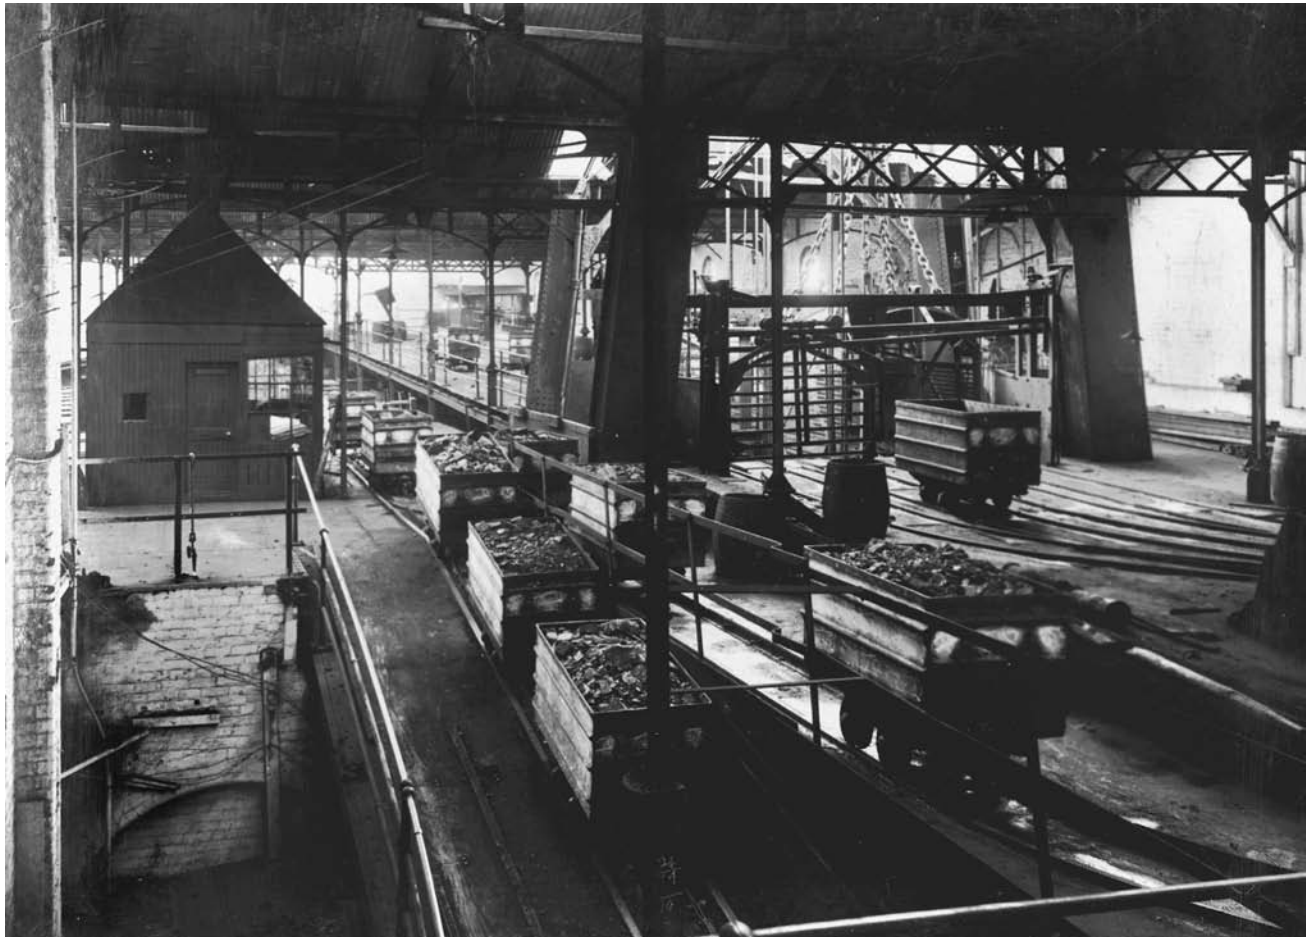
Figure 4.11: Lady Victoria Colliery, 1924. View showing the pithead, including the tub circuit and the top of the shaft. SMM:1998.0601.4, SC384784

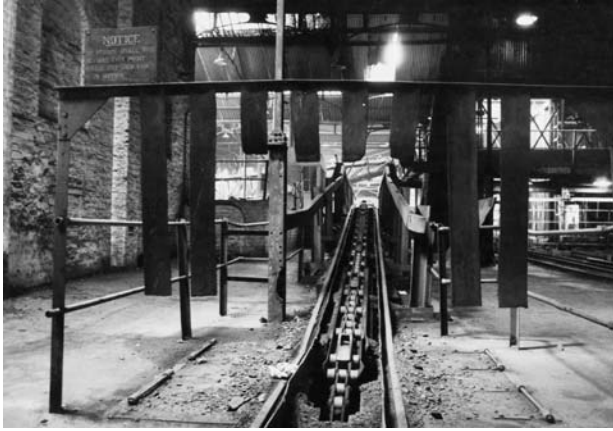
Figure 4.13: Lady Victoria Colliery. View of the 'creeper', which, after gravity had taken the tubs (or hutches) to bottom of the tub circuit, brought them back up to its summit at the pithead. SMM:1997.0893, SC382550

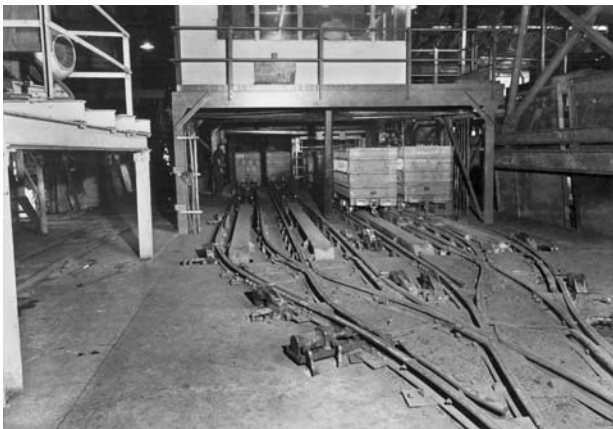
Figure 4.14: Lady Victoria Colliery, c.1981. View of the tub circuit and banksman's cabin, situated close to the top of the shaft, from where operations at the pithead were controlled. SMM:1997.0548, SC382549

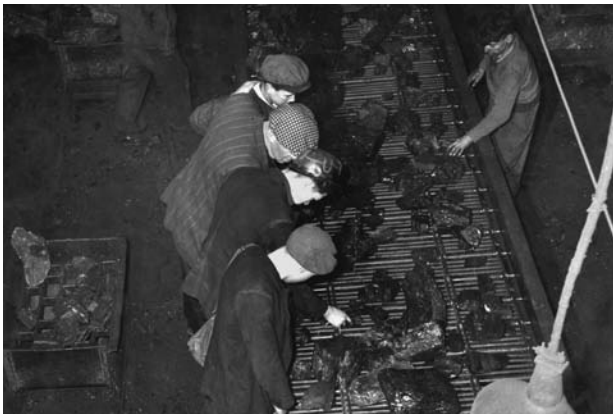
Figure 4.15: Lady Victoria Colliery, 1951. View looking down onto one of the picking tables. Sodium lighting was installed by the General Electric Company Limited in the 1950s because it made the coal glisten, in sharp contrast to the dull surface of the waste and dirt. SMM:1996.0861, SC384753

4 Picking Tables: accommodated at the upper level of the main pithead building's south-west end, and built partly between 1894 and 1907, and extended southwards by 1913, embracing the Dross Hopper. The most southerly portion was added after 1932. The tables were arrangements of slow moving conveyors from which lumps of stone and other waste were manually removed by teams of coal pickers (see Figure 4.15).

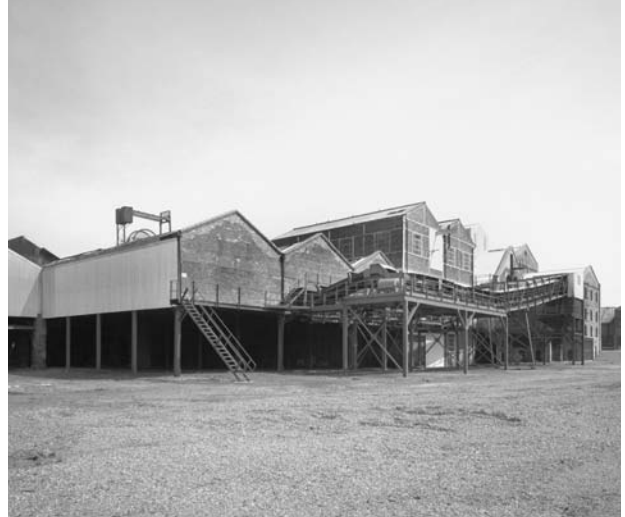
Figure 4.16: Lady Victoria Colliery, 1998. View of the south end of the colliery, showing the Dense Medium Plant (centre), which was constructed in 1963-4. SC894661

5 Dense Medium Plant: a form of 'washer' or wet coal-preparation plant added to the south end of the pithead buildings in 1963–4 (see Figures 4.16 and 4.17), and designed by Simonacco of Carlisle. It incorporated a washing process which used magnetite to raise the specific gravity of the 'waterfluid' in a large bath, permitting the separation of coal and stone. The magnetite was recovered and re-used using a magnetite recovery system.

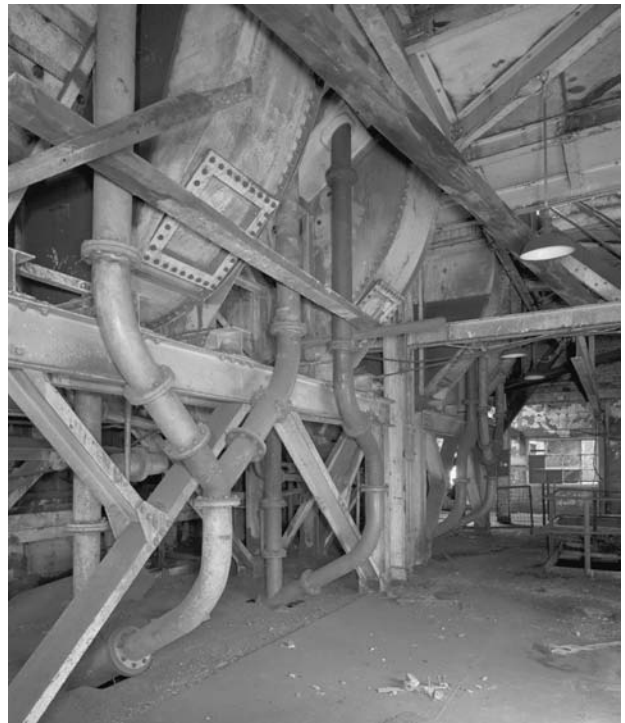
Figure 4.17: Lady Victoria Colliery, 1999. View inside the Dense Medium Plant, showing the bottom of the agitating vessels. SC894660

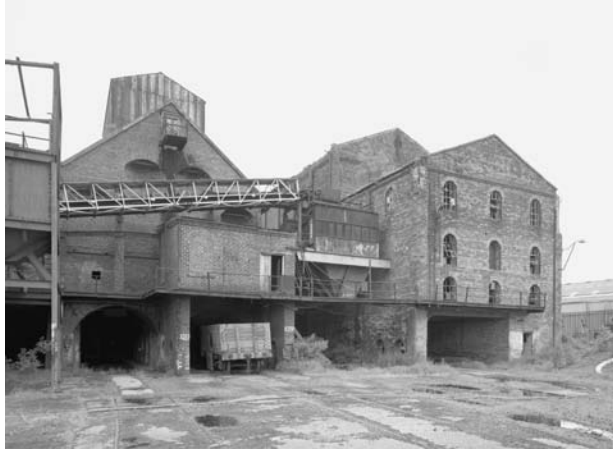
Figure 4.18: Lady Victoria Colliery, 1993. View of the south-east end of the colliery showing the cross Hopper (left) and the Old Washer (right). SC894265

When production first commenced in 1894, apart from the colliery's winding-engine house, boiler house and a small arrangement around the shaft itself, much of the colliery complex had yet to be developed (see Figures 4.4 and 4.33). For several years, therefore, coal was not washed, merely being sorted over screens and then dispatched by rail. By 1907, much of the current pithead had been constructed, the tub circuit and the picking tables being housed within steel-framed arcaded red-brick buildings, in the bottom of which ran railway sidings connected to the Waverley line (see Figures 4.8 to 4.15). Shortly afterwards (by 1914), the 'Old Power Station' (Figure 4.23) and the old 'Washer' (Figure 4.18) had been erected, the latter containing a 'bash-tank' coal preparation plant which operated until 1968, in combination with 'The Dredger' (Figure 4.30), a pitch-pine wooden structure at the north end of the colliery which treated dirty water from the washer, extracting coal dust which was later used to fuel the boilers. In the same period, the dross storage 'Hopper' (Figure 4.18) was built adjacent to the washer.

6 Hopper: a tall brick-built building, the walls of which have battered buttresses between which concave reinforcing panels helped to contain the weight of large quantities of coal dross within. Map evidence suggests it was built between 1907 and 1914 (see Figure 4.18).

7 Old Washer: a brick-built rectangular-plan building, constructed between 1907 and 1914, containing a felspar washer, to which was added on its south gable (by 1932) a smaller brick building containing a 'rewasher' designed to treat dross from the washer. The machinery of the latter has been removed, but the washer itself was retained after it fell out of use in the mid-1960s, and was renovated by the museum in the late 1990s (see Figure 4.18 and 4.19).

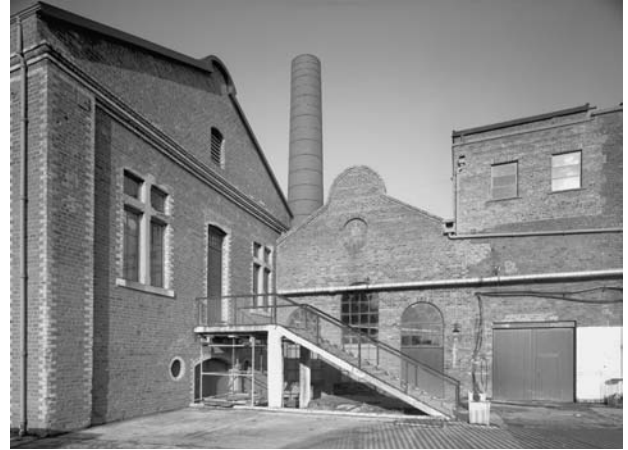
Figure 4.21: Lady Victoria Colliery, 1991. View of the Winding Engine House (left) and Old Power Station (right), with the boilerhouse chimney beyond. SC894659

9 Winding-Engine House: a gabled single-storeyed and basement polychrome brick rectangular building built between 1890 and 1894 to accommodate a 2,400 horse-power steam winding engine built by Grant Ritchie and Company Limited of Kilmarnock, said to be the largest ever to be erected in Scotland. A fire in 1902 destroyed the timber lining, and the internal walls were subsequently covered with ceramic tiles, and the floors with chequer-plate steel. After closure and the filling of the shaft, the engine was converted into an exhibit, and is now operated by an electric motor instead of steam (Figure 4.21 and 4.22).

18 Boiler-house Chimney: a circular-section brick stack, 1.6 metre diameter at its base, connected by a long brick-built flue to the boiler house, originally 46 metres high, but now reduced to 33 metres having been shortened on two occasions for safety reasons. This appears to be the same chimney as that built for the original boiler house, and probably therefore dates back to the establishment of the colliery between 1890 and 1894 (see Figure 4.21).

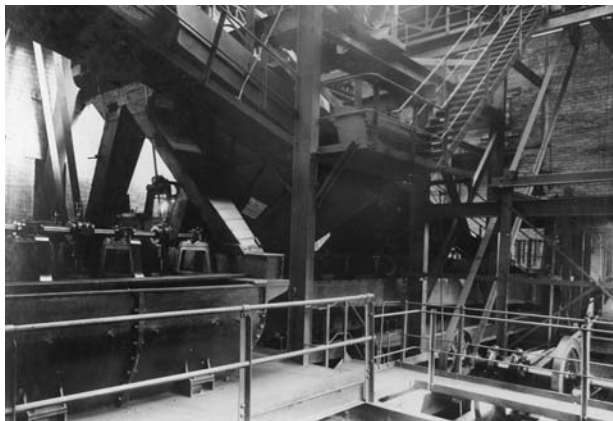
Figure 4.19: Lady Victoria Colliery, 1924. View within the Old Washer. SMM:1998.0601.7, SC384786

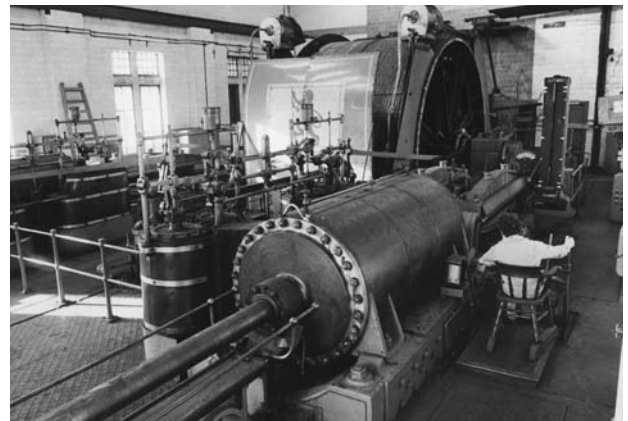
Figure 4.22: Lady Victoria Colliery. View of the steam-powered winding engine, which was built by Grant Ritchie and Company Limited of Kilmarnock. SMM:1997.918, SC382554

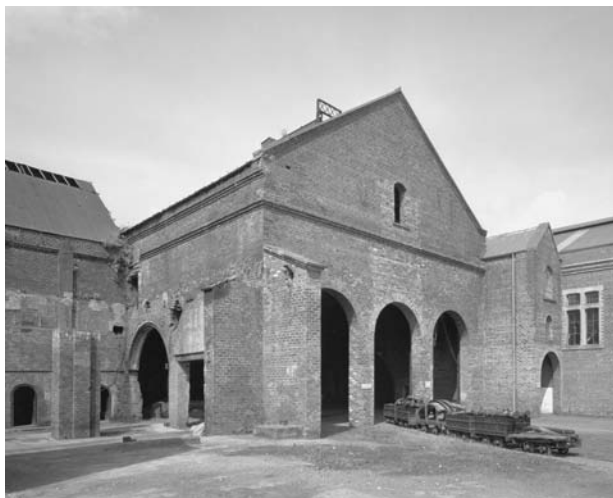
Figure 4.20: Lady Victoria Colliery, 1998. View from south east of the Smithy, prior to the conversion of its upper floor to an interactive exhibition area. SC894271

8 Smithy: situated on the east side of the pithead, a brick-built gabled structure erected in 1910. It contained a blacksmith's hearth and associated metal-working equipment, but was stripped and converted in the late 1990s to accommodate an interactive-exhibition area (see Figure 4.20).

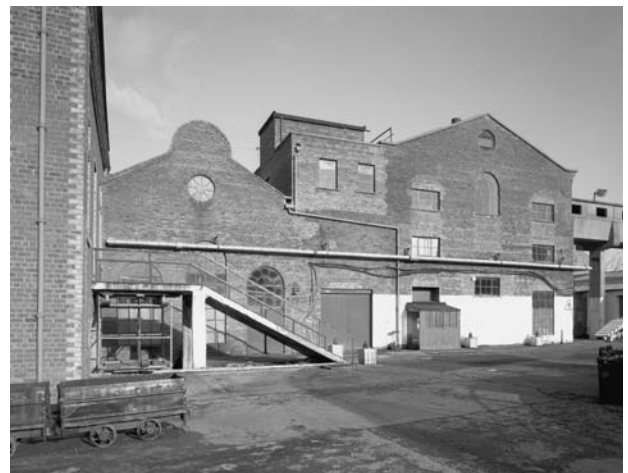
Figure 4.23: Lady Victoria Colliery, 1991. View showing the Old Power Station (left) and the New Power Station (right), before their conversion to house museum exhibits and visitor facilities. SC894272

10 Old Power Station: from early on, pioneering mining technology, including electrical machinery, was used at the colliery. A gabled brick-built rectangular single storeyed building, the colliery's first power station was built between 1894 and 1907, and generated electricity using two 1,000 kW Curtiss steam turbines. These were later relegated to reserve status after the introduction of a new 5,000 kW generator. In the late 1990s, the building was converted to house visitor and conference facilities for the museum (see Figure 4.23).

11 New Power Station: a tall brick-built rectangular-plan gabled building built in 1924 to replace the old power station, and to provide more electricity as mechanisation intensified at the colliery, and in the other two pits in the Newbattle group. After the mine ceased to generate its own electricity and was connected to the National Grid, the building was converted to offices, and in the 1990s, was used to house a range of new permanent exhibitions (see Figures 4.23 and 4.24).

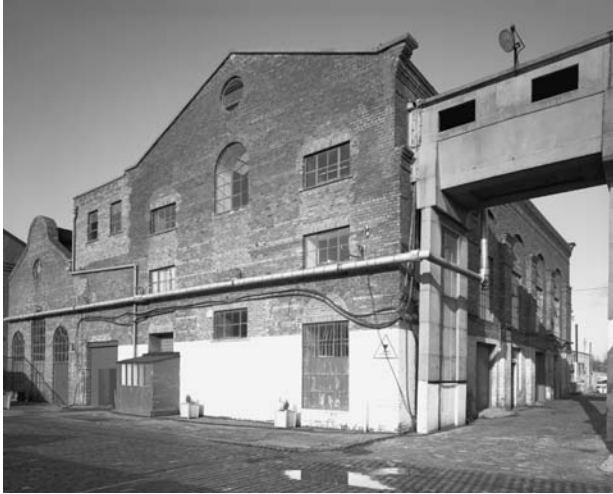
Figure 4.24: Lady Victoria Colliery, 1991. The New Power Station, before its conversion to house new museum exhibition areas and visitor facilities. The gantry to the baths can also be seen (top right). SC894669

Between 1914 and 1932, the most important developments included the construction of the New Power Station in 1924 (Figure 4.24), and a of new Boilerhouse (Figure 4.29) which doubled the number of Lancashire boilers to 12 in order to provide extra steam for electricity generation. The colliery workshops were added in the 1950s (Figures 4.27 and 4.28), as were the pithead baths (Figure 4.25), canteen and Scientific Laboratory. These were situated on the opposite side of the road from the pithead, and were connected by an overhead reinforced-concrete walkway or 'Gantry' which allowed miners to cross the road in safety. The last major development to occur at the colliery was the installation of the 'Dense Medium Plant' in 1963-4, a modern coal washery which was situated at the southern end of the pithead (Figures 4.16 and 4.17). This was accompanied by the construction of the 'Fines Treatment Plant' and 'Thickener' at the north end of the complex (Figure 4.32), this facility eventually rendering the old 'Washer' and 'Dredger' redundant.

13 Gantry from pithead to the baths and canteen: a re-inforced concrete overhead walkway built in 1954 to the design of NCB Scottish Division architect Egon Riss. It provided covered access over the A7 trunk road from the baths and canteen, first to the lamproom (in the upper level of the 'New Power Station'), continuing on to the pithead (see Figure 4.24 and 4.25).

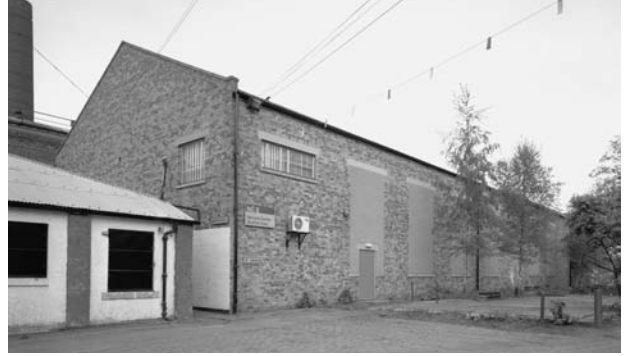
Figure 4.27: Lady Victoria Colliery, 1998. View of the former Colliery Workshops, converted into an archive centre for the NCB's Scottish Division, and later rented out to external users. SC894667

16 Colliery Workshop: dating from the 1950s, a gabled brick building where the maintenance and repair of the colliery's machinery was carried out. Following the closure of the colliery, an extra floor was inserted and the building was converted to become the NCB's Newbattle Archive. It has since been rented out for document storage (see Figures 4.27 and 4.28).

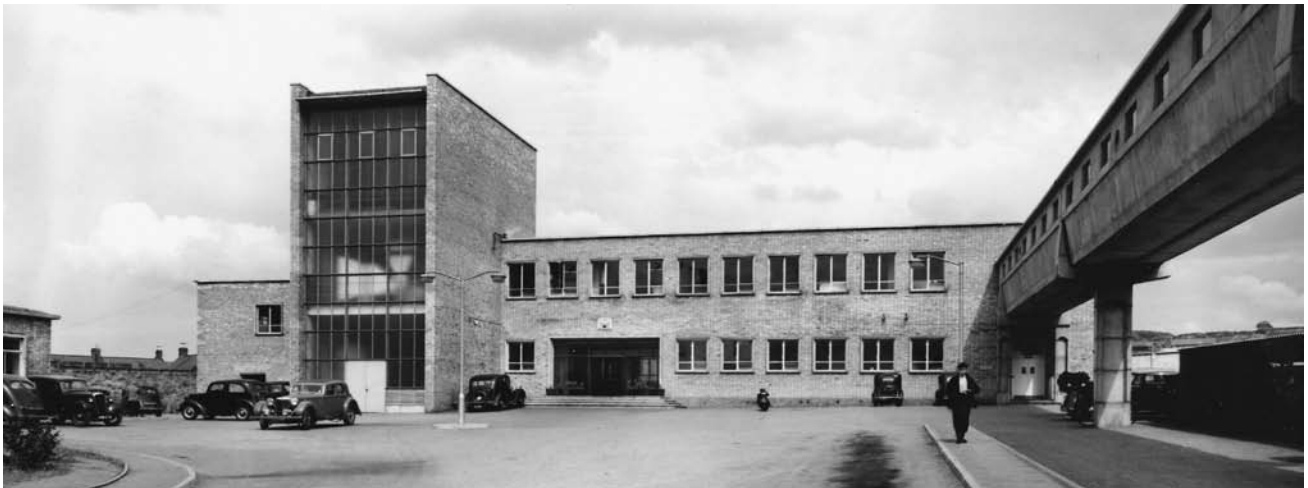
Figure 4.25: Lady Victoria Colliery, 1955. The pithead baths, which were situated on the opposite side of the main road (the A7 from Edinburgh to Carlisle). They, and the gantry connecting them to the pithead, were completed in 1954. The baths were demolished shortly after the closure of the colliery in the mid-1980s, but the gantry has survived. SMM:1998.0395, SC384761

15 Baths (out of picture): a single-storeyed brick-built building constructed in 1953, containing showers and lockers for up to 3,020 miners, and situated at the far end of the overhead gantry. The baths were demolished in 1986 (see Figure 4.25).

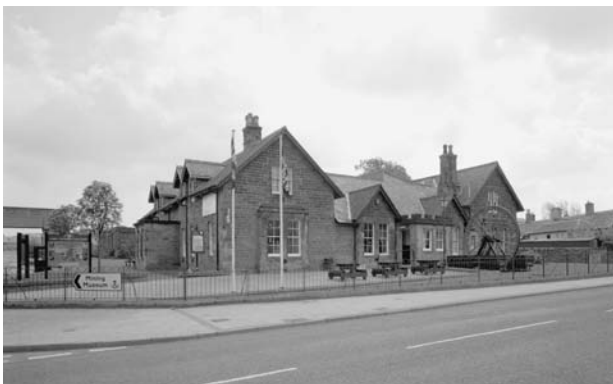
Figure 4.26: Lady Victoria Colliery, 1998. The former offices of the Lothian Coal Co. Separated from the pithead by the A7 trunk road (from Edinburgh to Carlisle), and used latterly as the offices of the Scottish Mining Museum. The building also houses the museum's excellent library and archive. SC894269

14 Lothian Coal Company Offices (out of picture): possibly built in 1873 originally as a school, a two-storeyed 'U'-plan rubble-built block, now occupied by the Scottish Mining Museum's administration, and its extensive library and archive (see Figure 4.26).

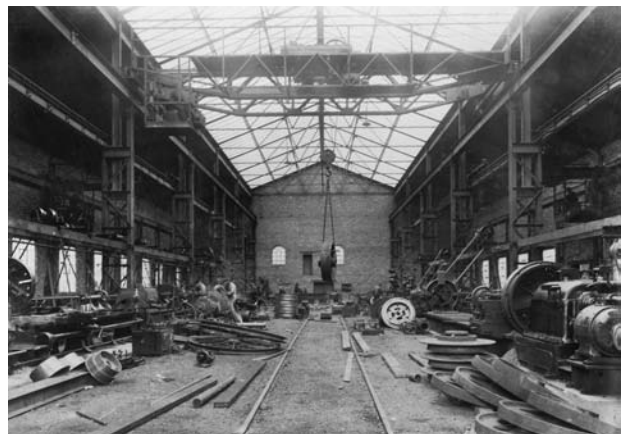
Figure 4.28: Lady Victoria Colliery, 1924. Interior view of the Colliery Workshop, prior to its conversion to an archive centre for the NCB's Scottish Division. SMM:1998.0601.12, SC384790

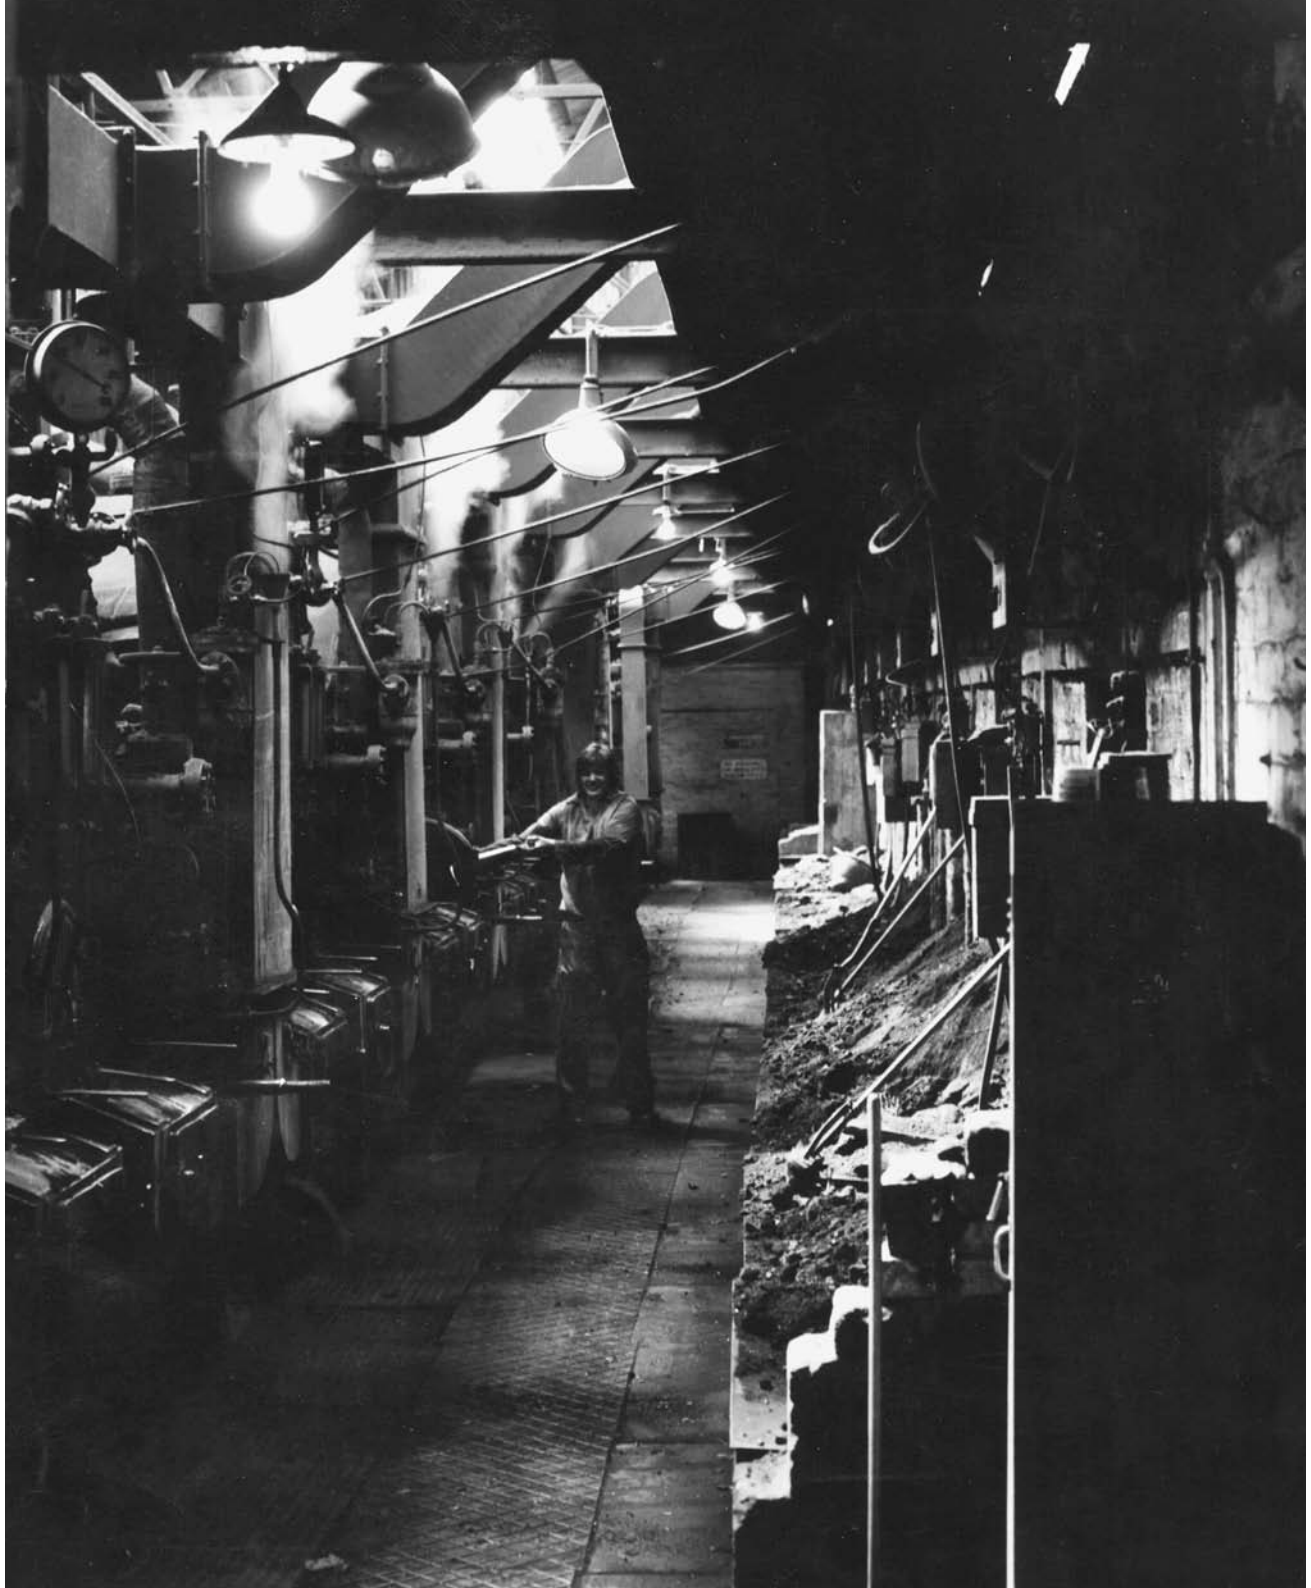
Figure 4.29: Lady Victoria Colliery, c.1970. Interior view of the Boiler House, which at its peak contained 12 Lancashire boilers producing steam to power the steam-winding engine, the power stations' generators, and for a variety of other uses in the colliery

complex. The boilers burned dross retrieved by the 'Dredger' from waste water emanating from the 'Washer', and later from the 'Fines Treatment Plant'. SMM:1997.0888, SC382558

17 Boiler House: built in 1924, the current building retains eight of its original 12 Lancashire boilers and associated economisers, and replaced an earlier boiler house (which contained six Lancashire boilers). They were bought from the Gretna munitions factory, which had ceased to operate at the end of World War I. Steam was

produced to power the adjacent steam-winding engine, to generate electricity, and to provide heat and process steam in various parts of the colliery complex. The boilers remained in operation until the closure of the colliery in 1981, and used coal dust retrieved from the 'Dredger' and 'Fines Treatment Plant' (see Figure 4.29).

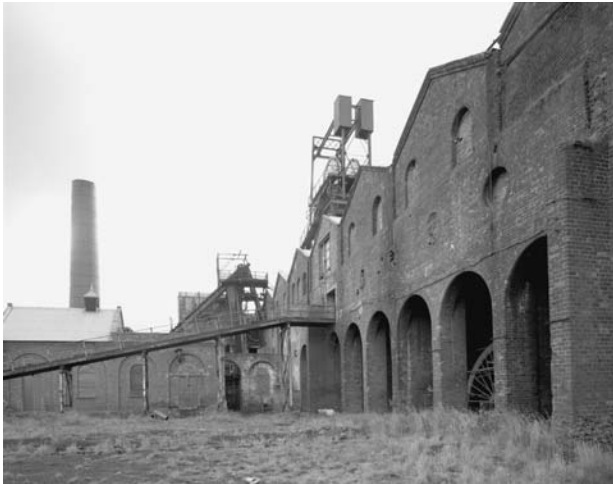
Figure 4.30: Lady Victoria Colliery, 1988. View of the 'Dredger', situated between the boilerhouse chimney (left) and the headgear (right). Its function was to extract by means of a bucket elevator coal dross at the bottom of a settling tank containing water from the old Washer, the dross being used to fuel the boilers in the adjacent Boiler house. SC894668

19 Dredger: a wooden pitch-pine structure within which dirty water from the 'Old Washer' was treated, bucket elevators extracting coal dust from the bottom of a settling tank. Also dating from between 1907 and 1914, it supplied coal dust for use in the colliery's boilers, but ceased to operate in the mid-1960s not long after the installation of the 'Dense Medium Plant' and the new 'Fines Treatment Plant' (see Figure 4.30).

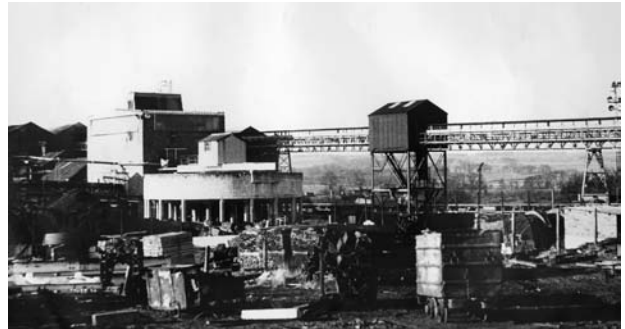
Figure 4.32: Lady Victoria Colliery, c.1965. View of the Fines Treatment Plant and Thickener, the construction of which in 1963-4 coincided with the installation of the Dense Medium Plant at the south end of the colliery. SMM:1996.0666, SC384760

20 Thickener: built in the mid-1960s, a circular concrete settling pond within which coal dust from the adjacent 'Fines Treatment Plant' was collected before being burned in the colliery's boilers (see Figure 4.32).

21 Fines Treatment Plant: built in 1963–4 on the north side of the colliery, it comprises a tall rectangular brick-clad structure within which dirty water from the 'Dense Medium Plant' was washed (see Figure 4.32). It operated in conjunction with the Thickener, waste material being taken away by overhead conveyor to the colliery's bing.

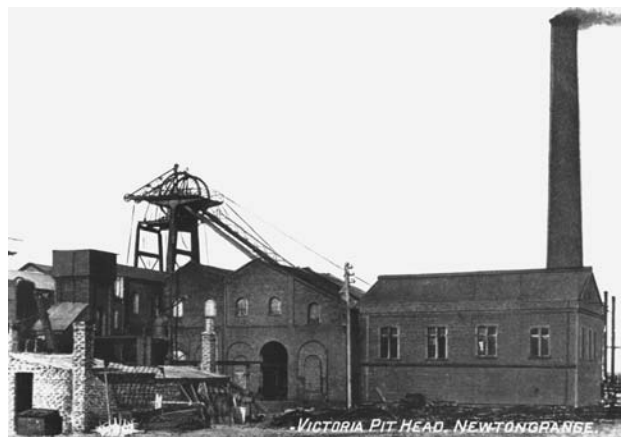
Figure 4.33: Lady Victoria Colliery, c.1895. This view shows the pithead shortly after the colliery came into production, and before the addition of other buildings around the pithead, including the Old Power Station. SMM:1997.0980, SC382551

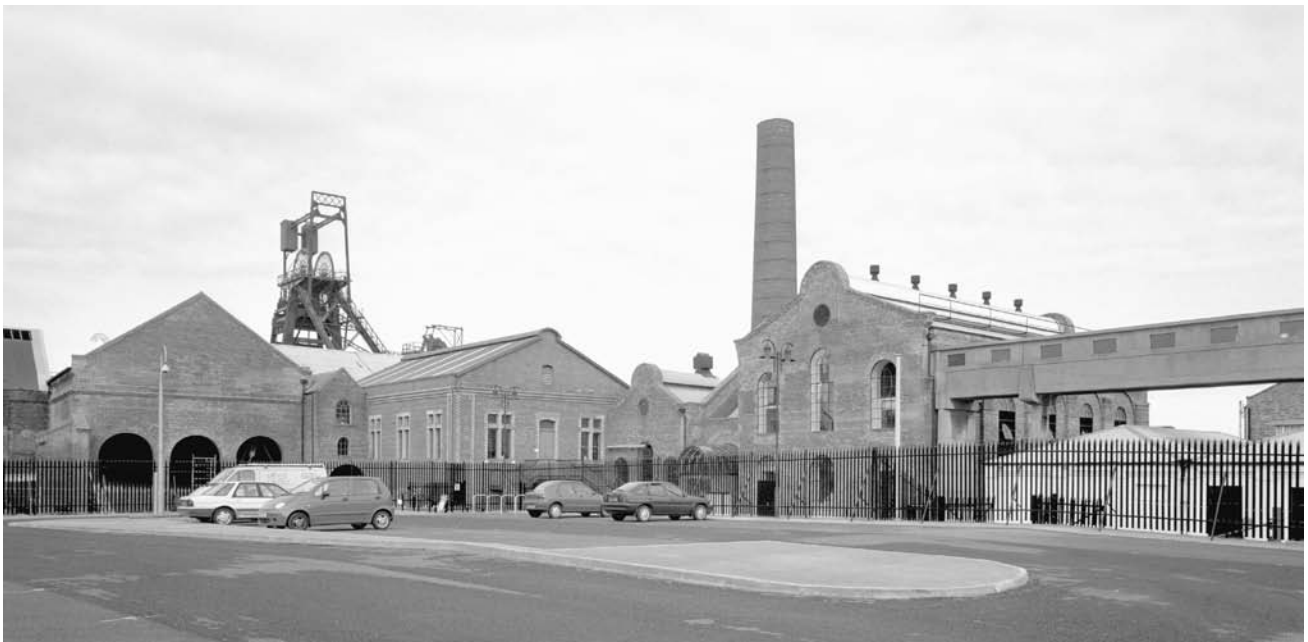
Figure 4.31: Lady Victoria Colliery, 1999. View of the pithead in 1999 after the completion of a £5 million renovation and redevelopment programme by the Scottish Mining Museum. SC894268
